How a Hydrostatic Pressure Test Proved the Effectiveness of an Innovative Secondary Containment System

Justrite® PolySeam® Liner System Is Low-Maintenance and Leakproof

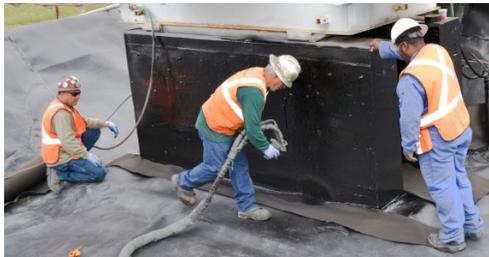
Sealing transformer pad with PolySeam.

The installation began by power washing the transformer pad to create a clean surface. Once completed, installers vacuumed out the remaining liquid. Justrite then applied the PolySeam system to seal the liner to the transformer pad. They supplemented the area around the base of the pad with geotextile fabric and sprayed accordingly.

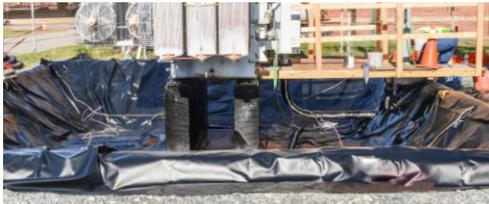
XR-5 liner ready for PolySeam application.

Next, the team laid the XR-5 panels according to the pre-approved site drawing, hand welding the seams to provide a preliminary seal. Justrite used their proprietary primer to ready the seams, followed by the PolySeam system to create a leak-proof join.

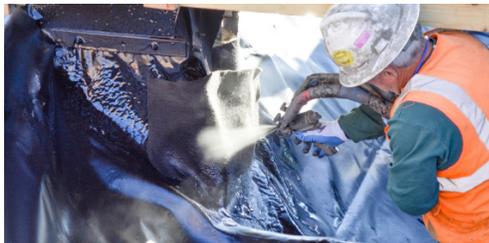
PolySeam easily bonds and seals irregular surfaces.

Experts from Justrite's secondary containment and industrial coatings solutions collaborated to develop an innovative design using an XR-5 liner and the PolySeam® System. The patented spray-on liner system eliminates the need for excessive cuts and joins around liner penetrations. PolySeam also serves as an alternative to traditional batten bar attachment and creates a flexible, yet durable, seal along HDPE and XR-5 liner seams.

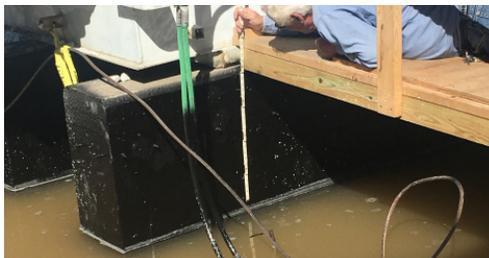
Performing hydrostatic pressure test

Hydrostatic pressure tests are commonly performed to check components such as pipelines, boilers and other pressure vessels for strength and leaks. To pass the test, the pit could lose no more than 1 inch of water in a 24-hour period, after factoring in evaporation.

Once the pit was half filled with stone, the team added water up to an agreed height. They established a control box outside the pit to evaluate evaporation. They added water and measured the starting height. After 24 hours, they measured the height again. They found only $\frac{1}{4}$ inch of water loss taking evaporation into account. The success of the project even surpassed the utility operator's high standards.
